# FORM B - Building

Town Groton  
Place (neighborhood or village) Groton Center

Address 97 Hollis Street  
Historic Name Mansur House  
Uses: Present Residential  
Original Residential  
Date of Construction c. 1880

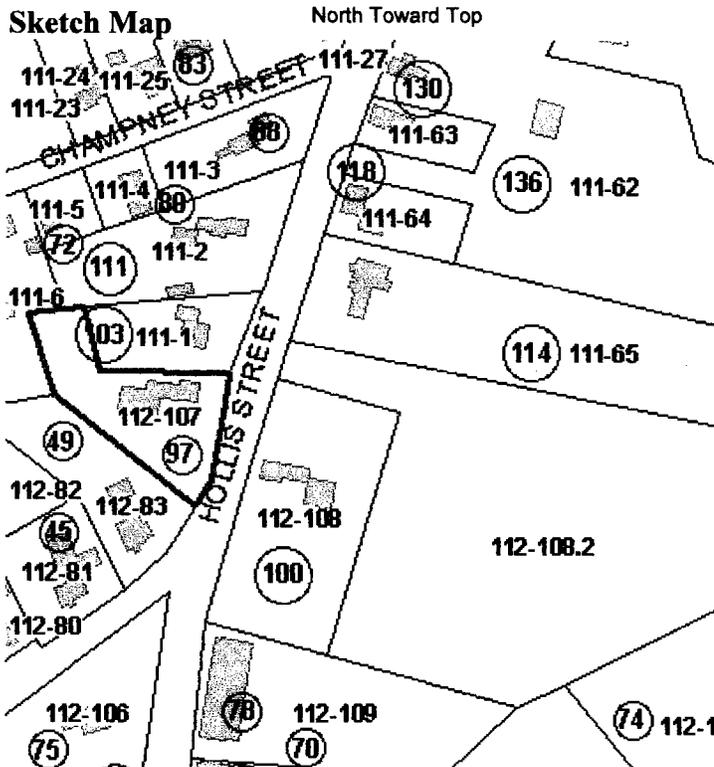
- \* The house at 97 is a Second Empire style, 2 1/2-story, 3x3-bay cross-gambrel form with a 2-story rear ell and attached barn; the upper section of the roof is a gabled form; the lower pitch of the Mansard roof has an inverted bell curve; the façade is a front gambrel form; a wrap-around porch with eave trim similar to that on the house covers the first story on the south and east elevations

- \* Decorative features are the paneled corner pilasters, paired brackets and molded cornices at the eave and at the junction of the two roof slopes
- \* Windows are mainly 2/2 double-hung sash with round-topped dormers in the upper story of the side elevations; window trim is beaded and includes slim hood moldings; openings in the first story of the façade are extended in length

- \* The side-hall entry has relatively simple beaded trim
- \* A single brick chimney rises from the core of the plan
- \* The rear ell is composed of a 2-story flat-roofed section against the rear of the house connecting to the barn; this was added after initial construction according to the current owner

- \* The barn has a Mansard roof with a gambrel wall gable in the facade; access is through a central rolling vehicle door; additional openings in the principal elevation contain 2/2 double-hung sash, pedestrian door and mow door; a molded cornice separates the 2 roof slopes here as well as on the house; siding is vertical flushboard

- \* The house is in good condition and is very similar in form, design and scale to those at 96 and 111 Hollis Street
