BUILDING FORM

Town
Groton

111 Hollis Street

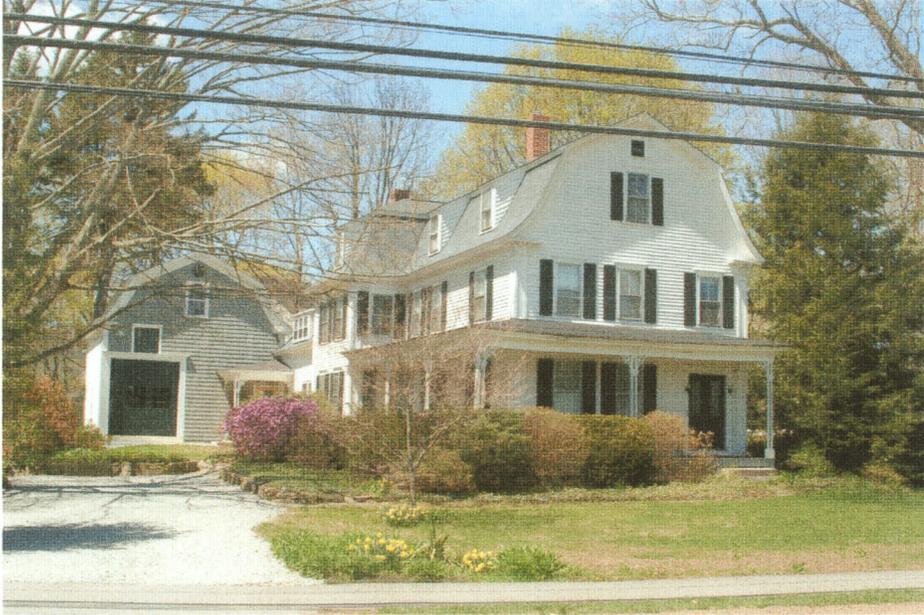
- * The house at 111 is a Second Empire style, 2 1/2-story, 3x3-bay cross-gambrel form with a 1 1/2-story rear ell and attached barn; the upper section of the roof is a gabled form; the lower pitch of the Mansard roof has an inverted bell curve; the façade is a front gambrel form; a wrap-around porch with jigsawn brackets and paired posts covers the first story on the south and east elevations; an open porch with matching posts and brackets covers a secondary entry at the junction of the ell and main block

- * Decorative features are the paneled corner pilasters, paired brackets and molded cornices at the eave and at the junction of the two roof slopes
- * Windows are mainly 2/2 double-hung sash with round-topped dormers in the upper story of the side elevations; window trim is beaded and includes slim hood moldings; openings in the first story of the façade are extended in length; shed dormers occupy the upper roof slopes; The side-hall entry has relatively simple beaded trim with a slim hood molding

- * Two brick chimneys rise from the core of the plan
- * The rear ell is composed of a 1 1/2-story gable-roofed section against the rear of the house connecting to the barn

- * The barn has a gambrel front Mansard roof; access is through an off-center rolling vehicle door; additional openings in the principal elevation contain 6/6 double-hung sash, pedestrian door, oculus in the peak and mow door; a molded cornice separates the 2 roof slopes here as well as on the house; siding is wood shingle

- * The house is in good condition and is very similar in form, design and scale to those at 96 and 97 Hollis Street
