FORM B - Building

Groton Center

Address 11 Station Avenue

BUILDING FORM

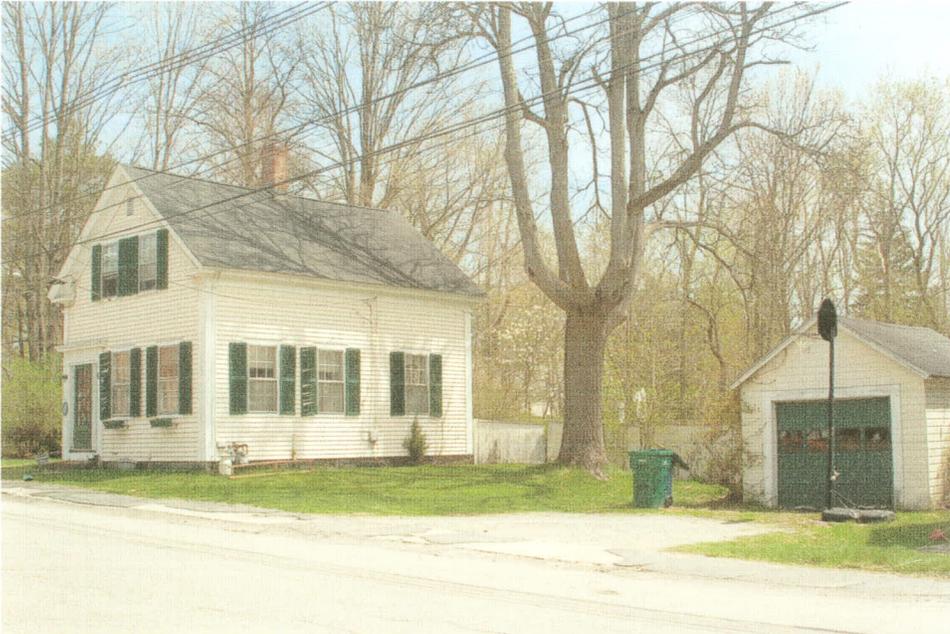
- * The house at 11 Station Avenue is a 3x3-bay, front-gabled, 1 1/2-story Greek Revival style design with a 1-story gable-roofed ell at the east side of the plan
- * Windows are 6/6 double-hung units with plain trim
- * The side-hall entry is lit by full-length sidelights; trim consists of pilasters and entablature above
- * Decorative features are the gable returns, corner boards, frieze on the eave sides and molded cornice; a secondary entry gives access to the west side of the ell and has plain trim
- * The modestly scaled detached garage has 1 vehicle opening; siding is wood novelty board
- * The house and garage occupy a small parcel between Town Hall and the industrial section of Station Avenue; The house is smaller than most others in the center but is comparable to others on the outskirts of the center village such as the house at 56 Boston Road
