FORM B - Building

Address 112 Farmers Row
Historic Name Dickson House
Uses: Present Residential
Original Residential-agricultural
Date of Construction c. 1800

112 Farmers Row

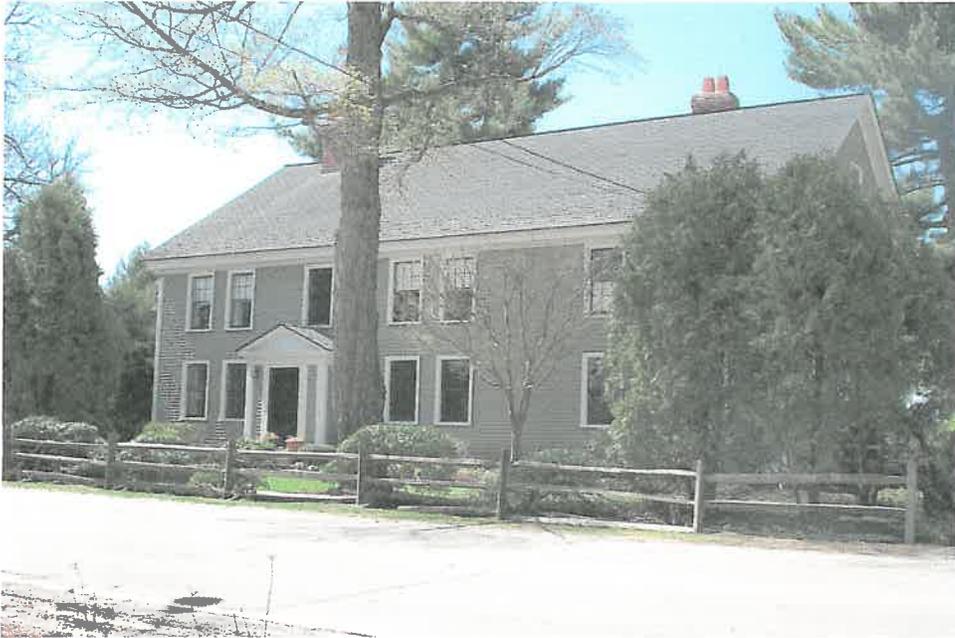
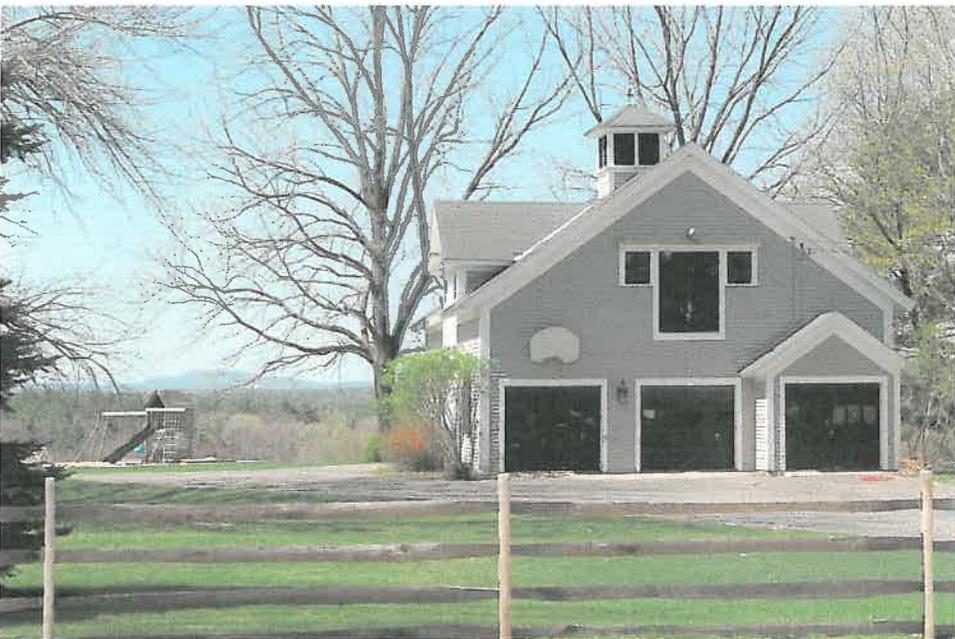
- * The Dickson House is a 7x3-bay, side-gabled, 2 1/2-story form with a 2-story rear addition at the southwest corner; The façade is arranged in five symmetrical bays in the south part of the façade and two additional bays that may have been added to the north wall subsequent to original construction; a vertical trim board separates the two sections

- * Decorative elements of the Federal style design include the molded cornice, corner boards, beaded window trim and gable returns; the off-center entry has an enclosed gable roofed porch trimmed with corner pilasters, entablature and pilasters flanking the door; brick chimneys rise from the front and rear slopes of the roof near the north and south ends

- * A post and rail fence separates the house from the road
- * The detached 19th century barn has a cross gable roof with square ventilator at the center, corner boards and molded eave trim; three garage modern doors, including one in a projecting gabled pavilion, give access to the interior from the street elevation; windows in the roof gables are double-hung sash and, in the upper level of the façade, flank a mow door; windows have stout hoods supported by brackets; door, window and eave trim are plain
