FORM B - Building

Town Groton
Place (neighborhood or village) Groton Center

Address 368 Main Street
Historic Name Herb Lyceum
Uses: Present Restaurant
Original Residential-agricultural
Date of Construction c. 1840

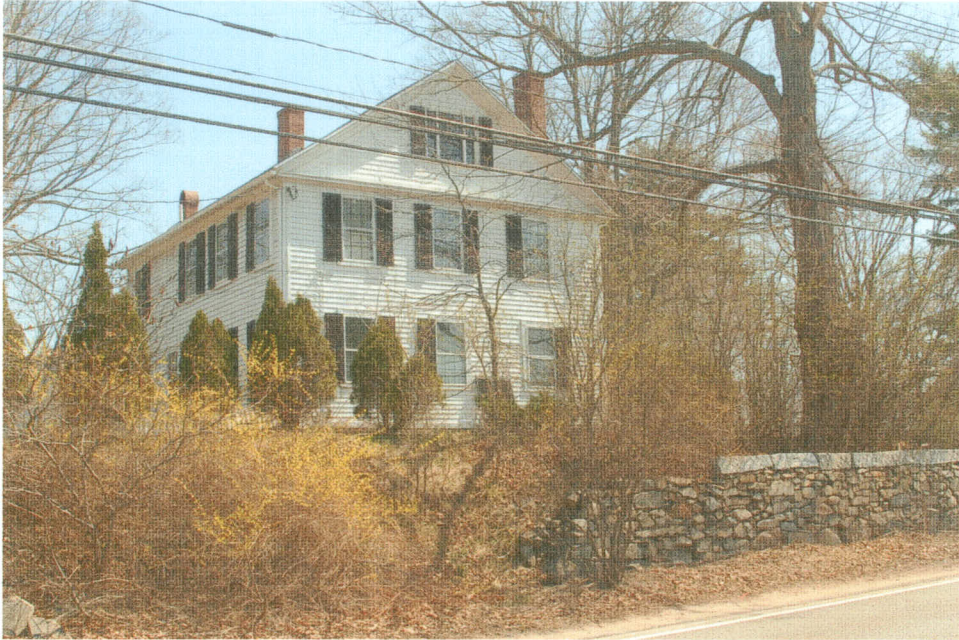
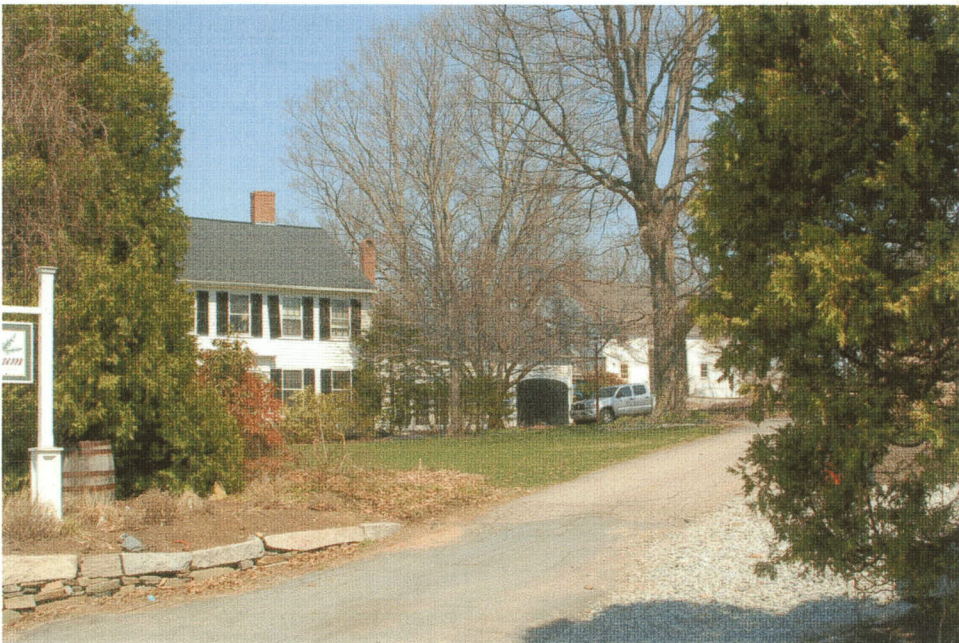
- * The Federal style house at 368 Main Street is a side-gabled, 5x3-bay, 2 1/2-story form with a 1-story shed projecting from the northeast elevation; The house is oriented perpendicular to the road; The gable roofed shed has three vehicle openings with arched tops

- * Decorative features consist of the symmetrical fenestration, classical surround with sidelights at the center entry, closed gable, molded cornice, corner boards and beaded window trim

- * Windows are mainly 6/6 double-hung sash with sidelights flanking the example in the southwest gable peak
- * Two tall brick chimneys rise from the ridge and from the front slope of the main roof; a third is atop the shed roof

- * The detached barn is difficult to see but appears to have a vehicle door in the southwest, wood clapboard siding and sparsely placed 6/6 sash; Additional outbuildings that are partially visible are greenhouses, some of which appear to be made of plastic sheeting but are unidentifiable from the road

- * The house and barn are well-preserved and retain integrity of materials and design; the site is elevated slightly above Main Street a short distance northwest of the town center
